FINAL REPORT FOR STA-2A NDT TESTING

MORTON THIOKOL, INC.

FINAL REPORT ON STA-2A NDT TESTING

25 NOVEMBER 1987

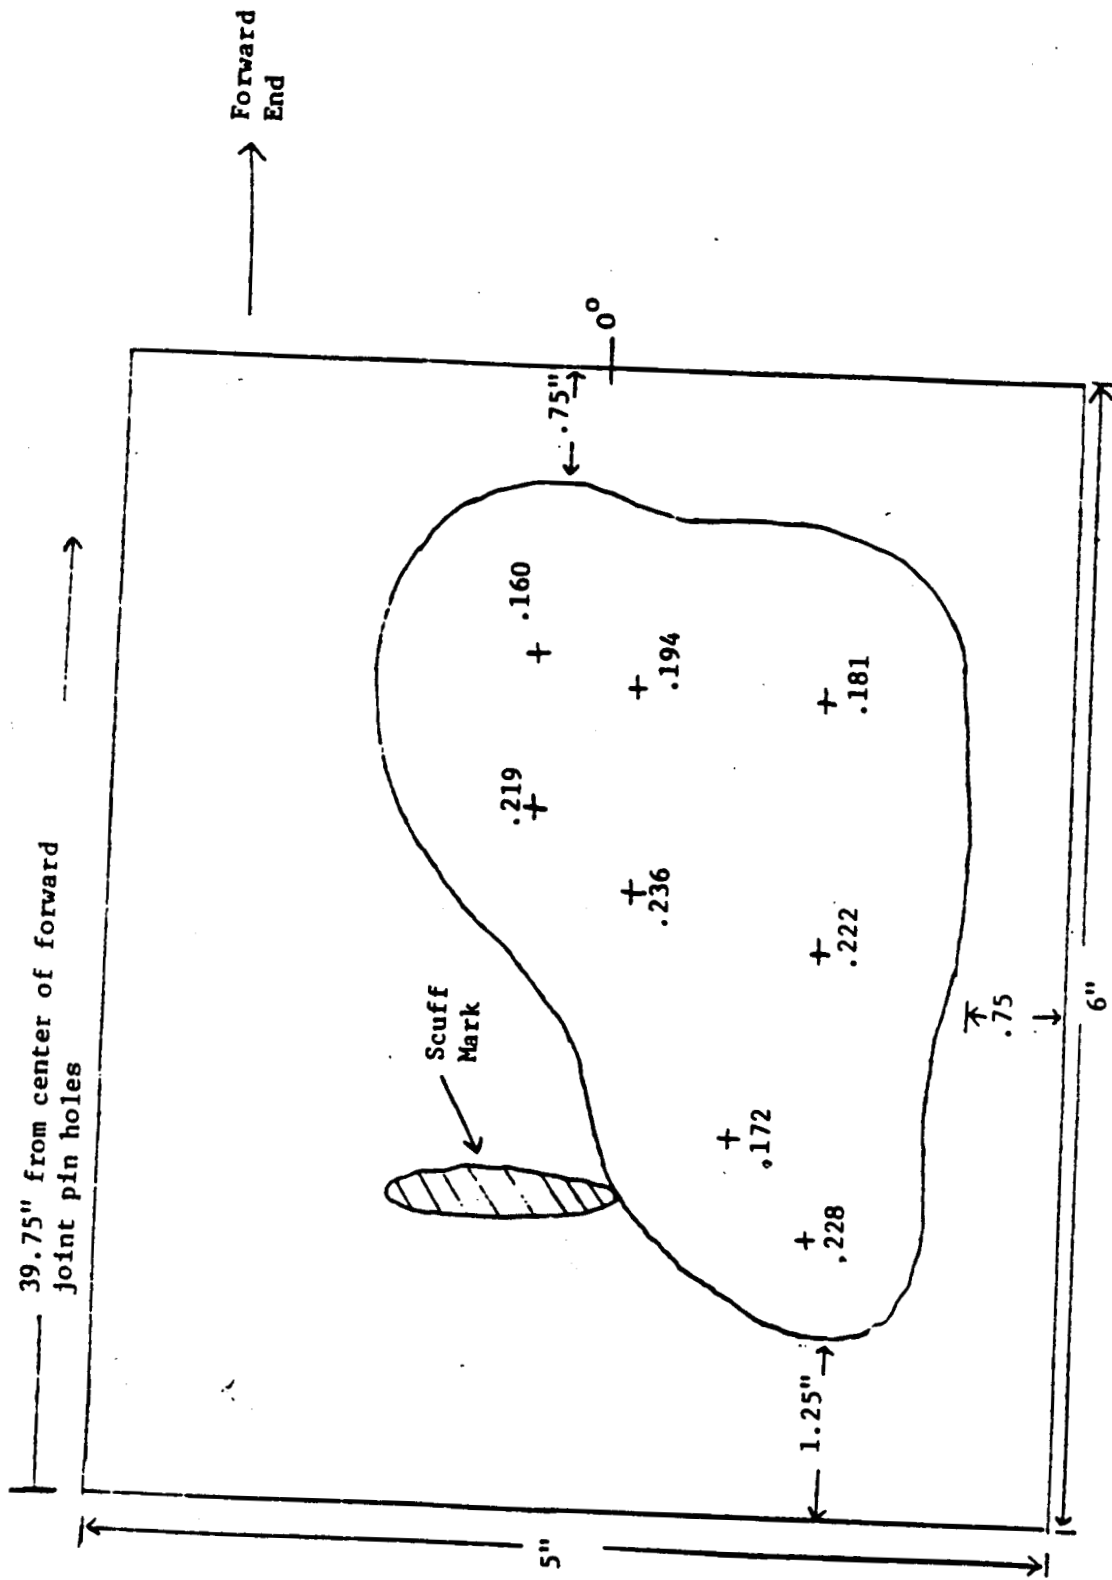
FIGURE 5. DR #4421. ITEM 1

A Pulse Echo inspection was performed on the areas listed in DR #4421 and DR #4473. These areas were hit or scuffed during shipping, installation, or instrumentation of the segments. Figures 5-8 show the results of the inspection. Items 3, 4 and 5 had no indications of subsurface damage. Bob Anderson of Hercules reviewed the recorded scans; Item 1 was not a delamination and was present on the sutra map. Interpretation of the recorded

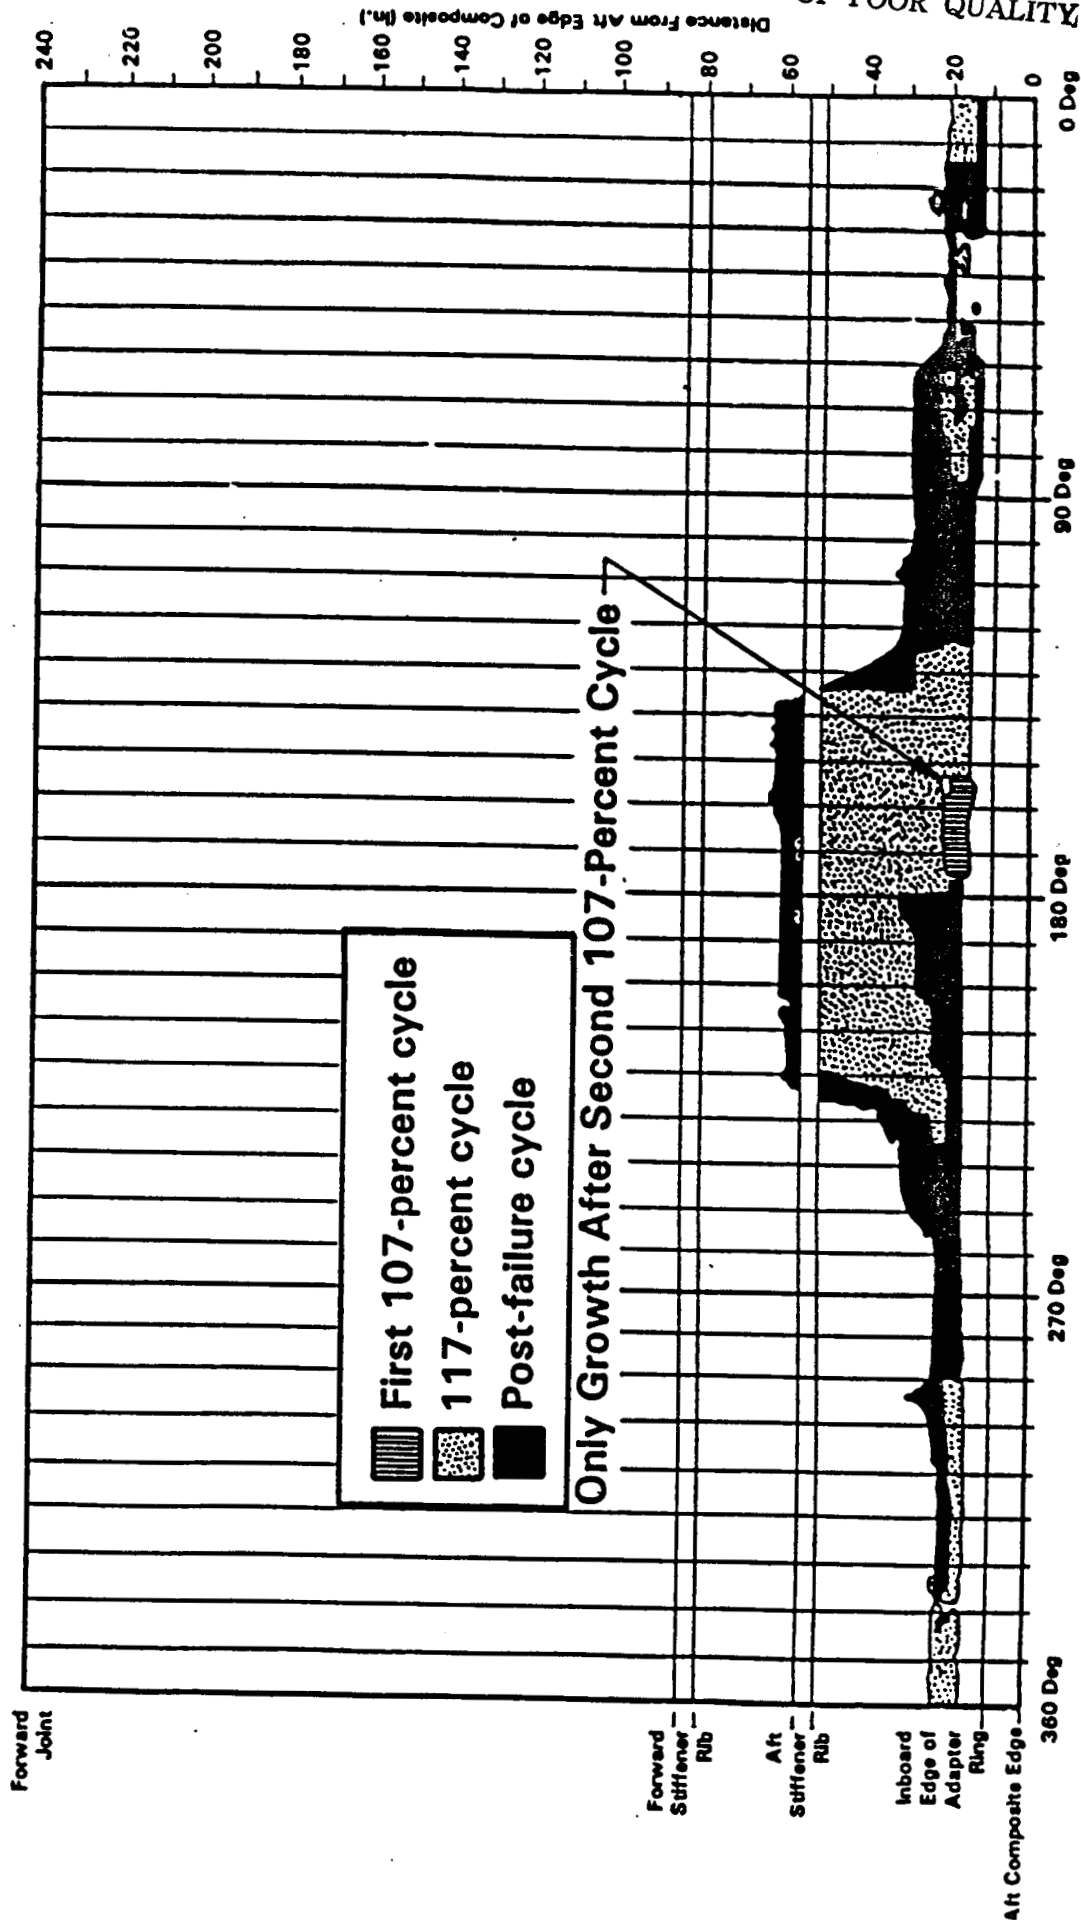
FIGURE 48.

The fifth load occurred 16 July, 1985. Figure 47, events vs. load, shows that significant defect growth occurred during this test phase. The known delamination area at 160 degrees on the Aft Transition region grew rapidly as the load exceeded 100 percent limit load. The data shows that the defect grew first in the circumferential direction, then in the forward direction, at higher load levels. The AE data indicated that Pulse Echo inspection was necessary. Results of the inspection are

shown in Figure 48. Pulse Echo data confirms the AE data on growth direction and defect locations. The defect growth shown by Pulse Echo agrees closely with the predicated stress analysis model.

Delamination after 117-percent load test and after failure at 118.4-percent load test

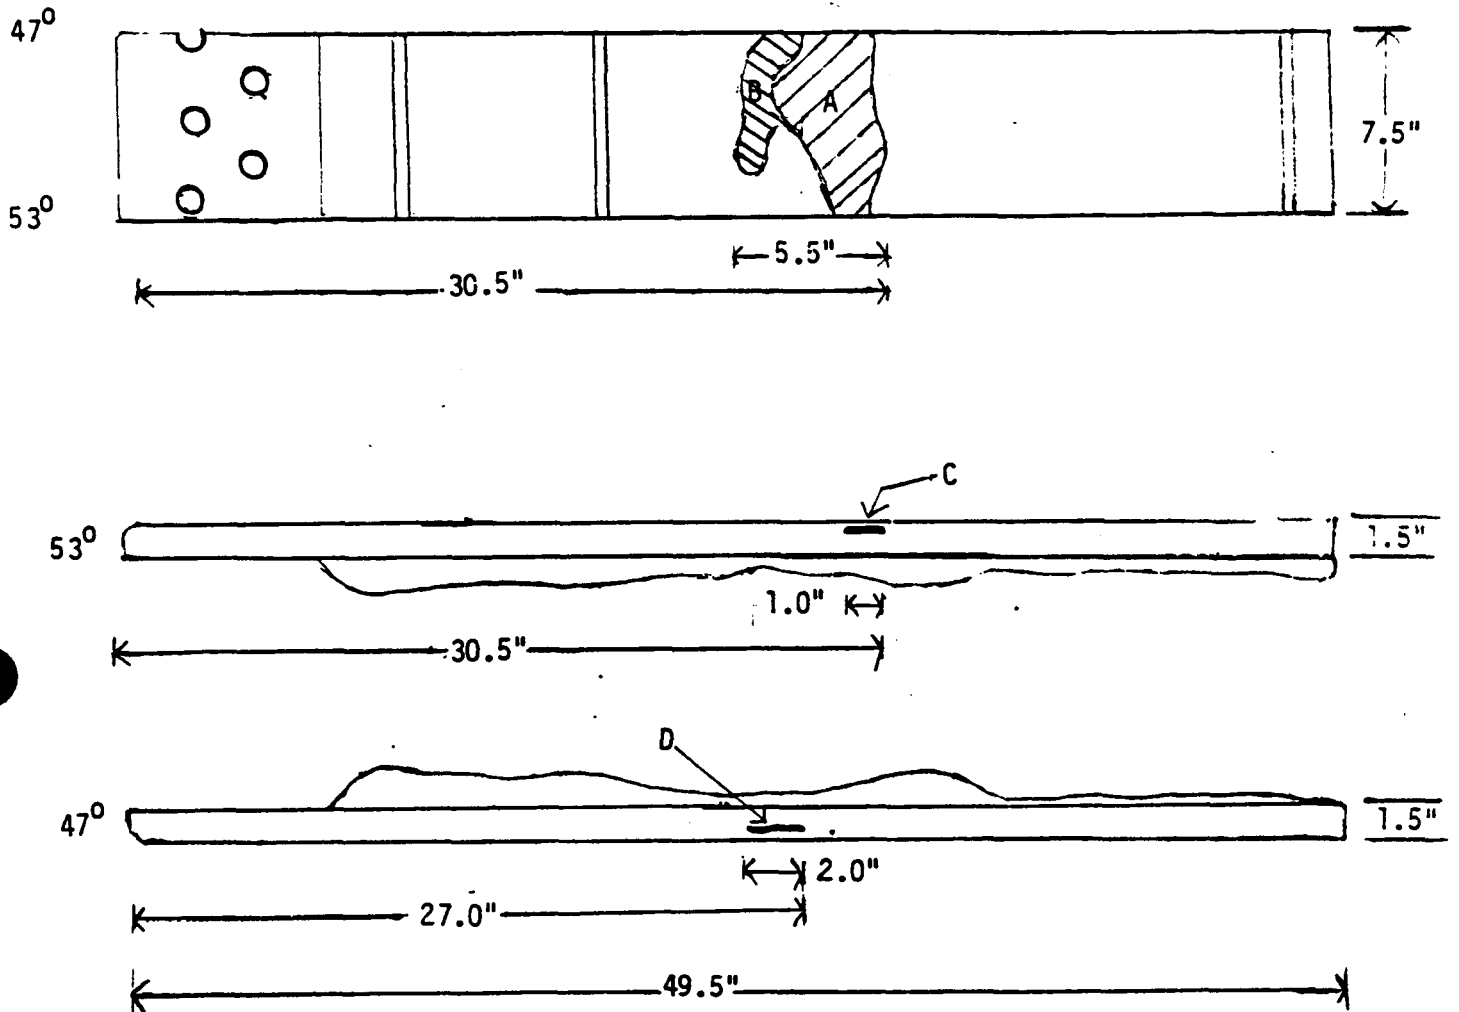
FIGURE 59. SAMPLE #12

- A. UT depth .074"
- B. UT depth .260"
- C. Mechanical depth .076"
- D. Mechanical depth .230" - .245"

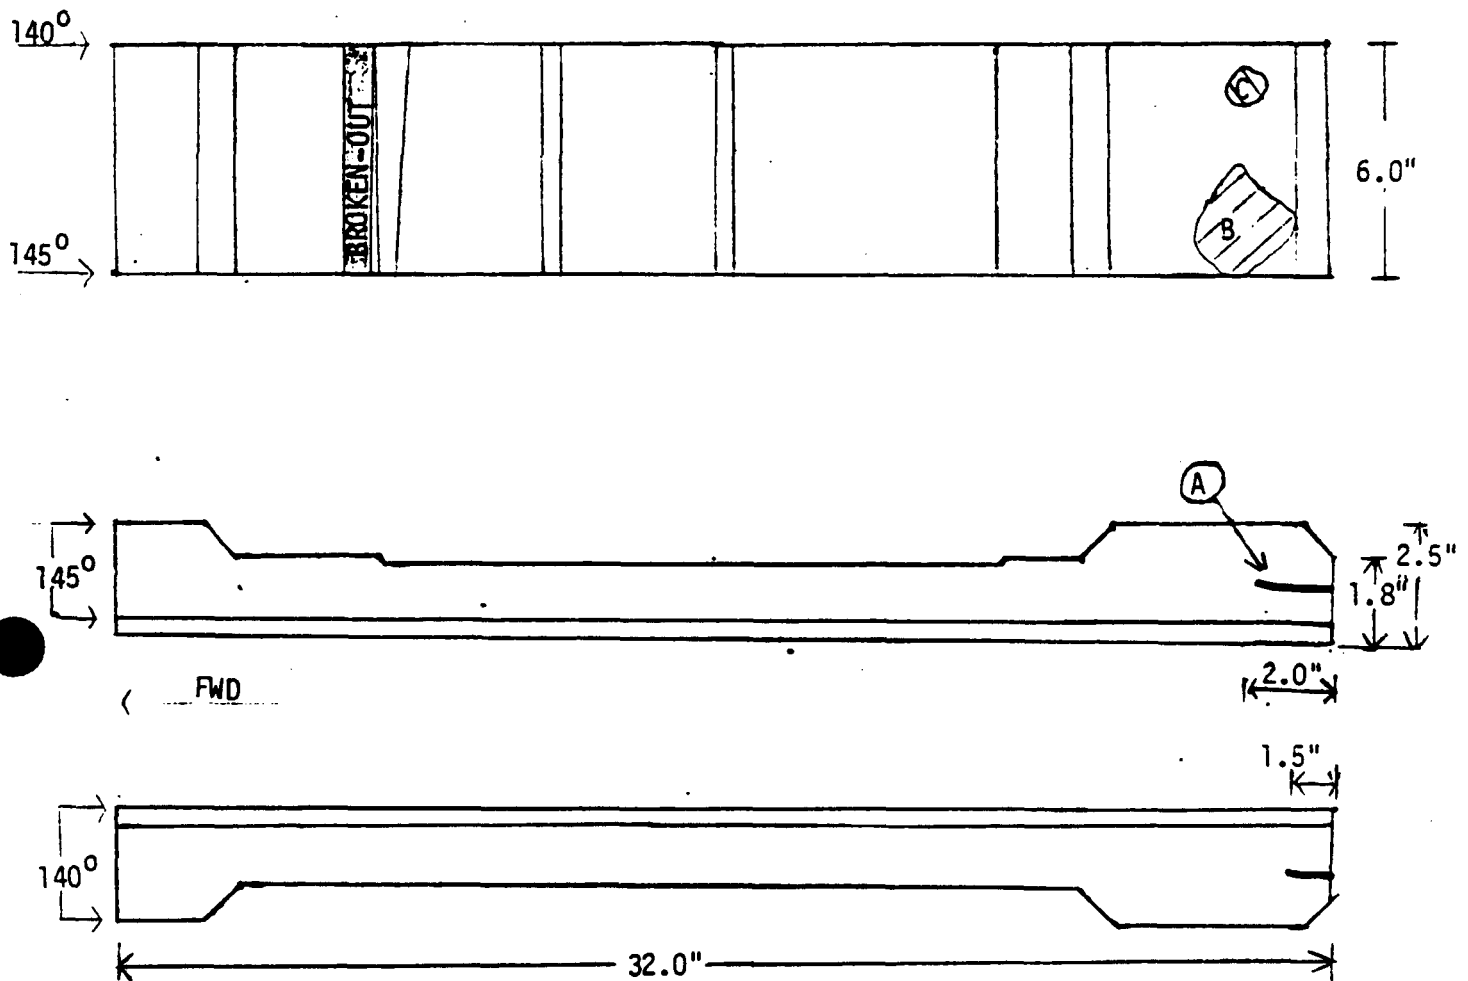
FIGURE 68. SAMPLE #18

- A. Scalar depth 1.515" from OD surface of Stiffener Rib.
Approx. scalar depth from OD cylinder .450". (ie - less Stiffener Rib).
- B. UT depth 1.715" (75% S/H).
- C. Small delam depth UT 1.734"
